## **St Lukes Chappel, Newcastle**

### **Case Study**

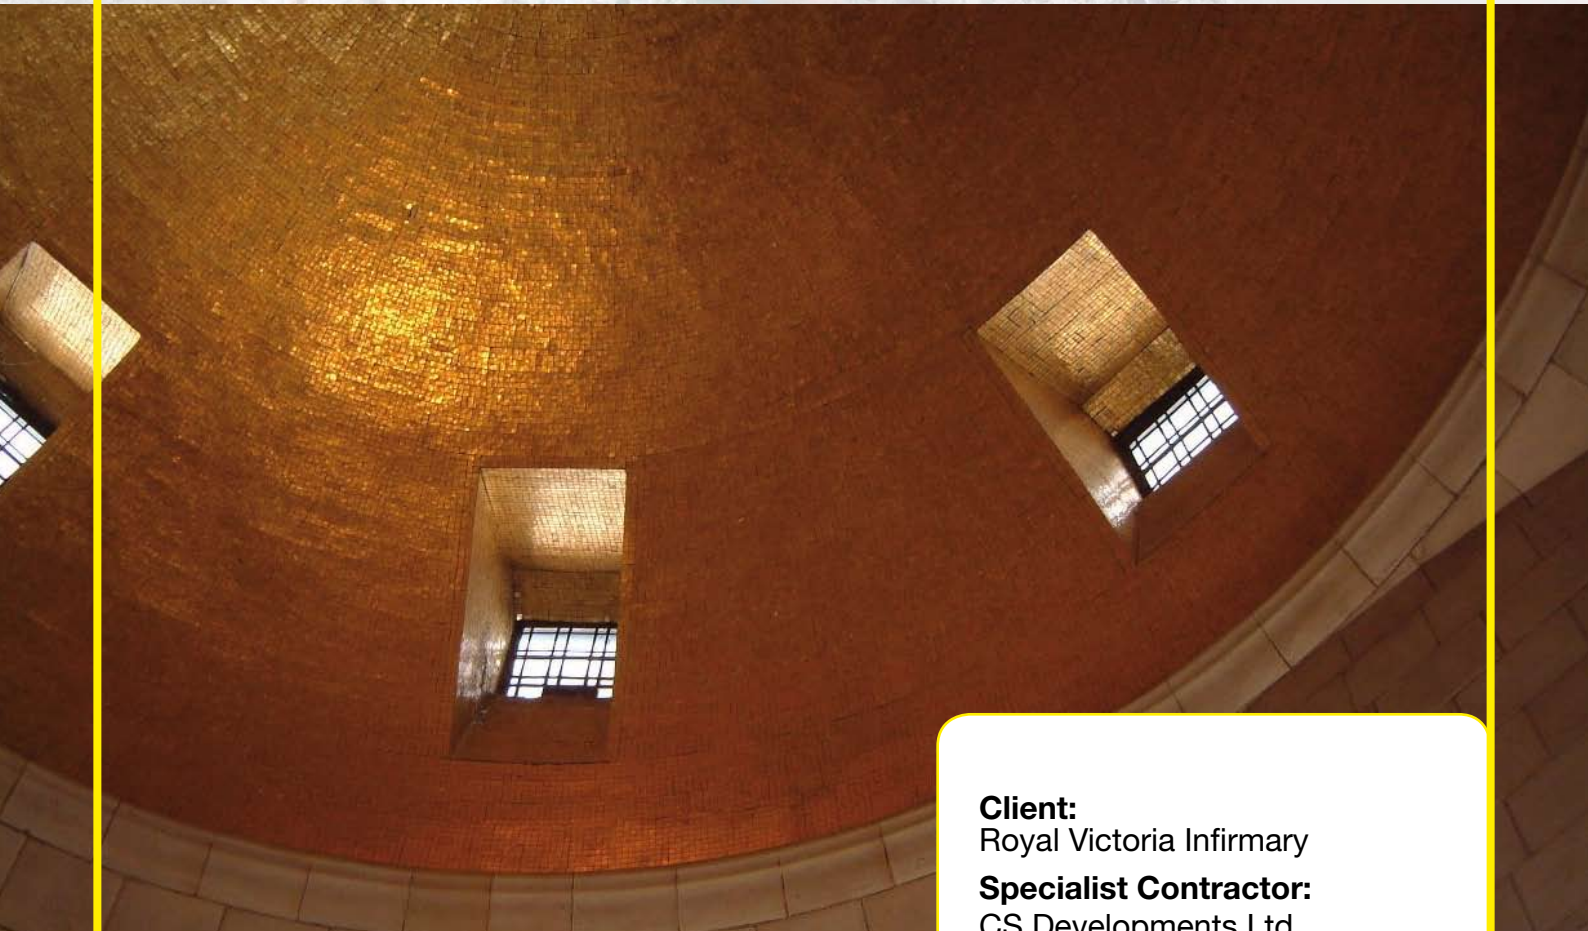
The domed concrete roof of St Lukes Chapel at The Royal Victoria Infirmary in Newcastle, had previously been waterproofed with a bitumen felt.

However this had deteriorated allowing water ingress into the concrete which had begun to crack and spall, putting the fine gold leaf and mosaic decoration of the internal surfaces at risk.

CS Developments Ltd and their materials consultants **NCC**, developed a complete Sika repair and protection system as a solution to repair, protect and waterproof the reinforced concrete dome.

The failed waterproofing was removed, together with the damaged concrete. The exposed steel reinforcement was cleaned and protected, then the damaged concrete was replaced with Sika MonoTop repair mortars. To prevent the development of any future corrosion in the carbonated concrete, the surfaces were impregnated with Sika FerroGard 903, which migrates to the embedded steel and forms a protective barrier.

Finally the surfaces were finished by coating them with elastic, crack bridging Sikagard 550W, followed by new leadwork from other specialists.
