Perstorp AB Warrington

Case Study

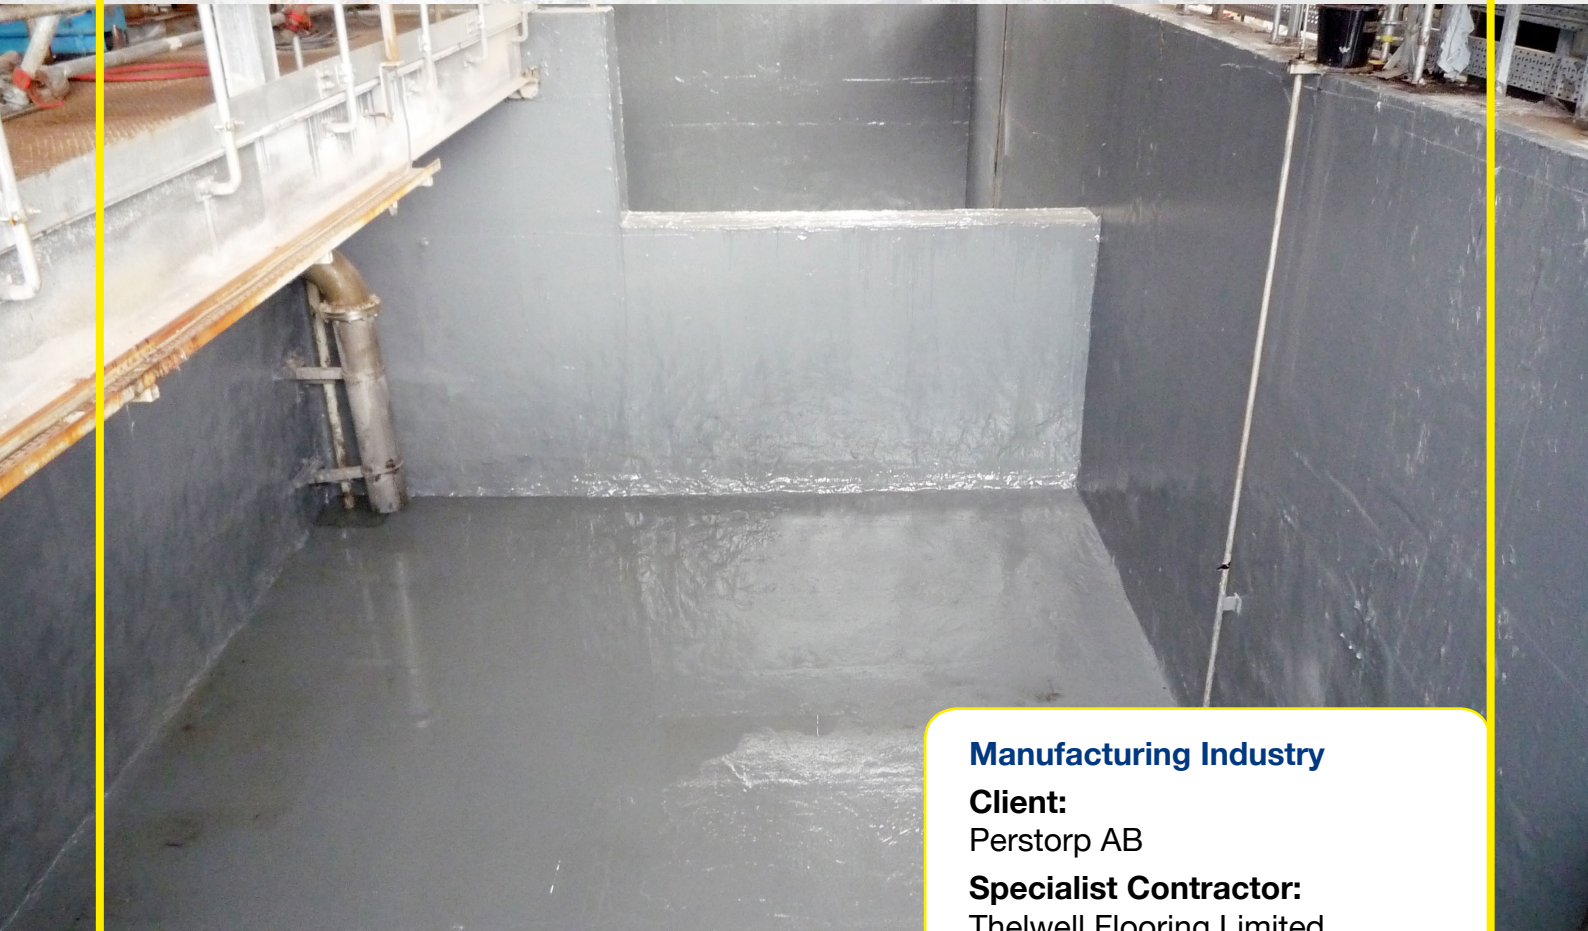
Perstorp's engineers observed in one of their four metre deep containment tanks, that the existing concrete surfaces had been visibly attacked in several areas and were starting to deteriorate overall due to this chemical corrosion. Therefore they decided to make a full scale refurbishment to ensure that it remained watertight for the long-term and was fully resistant to the chemicals involved, especially as some of them were highly acidic.

A full concrete repair and protection system solution was developed with Thelwell Flooring: All of the damaged concrete was removed mechanically followed by blastcleaning of all surfaces; the damage was repaired and made good with polymer modified concrete and mortars from NCC and allowed to cure; finally the surfaces were all coated with Atako ATB-300 GL, a highly acid and chemically resistant, vinyl ester based, glass fibre reinforced concrete protection system.
