## **Cullercoats Beach, Tynemouth**

### **Case Study**

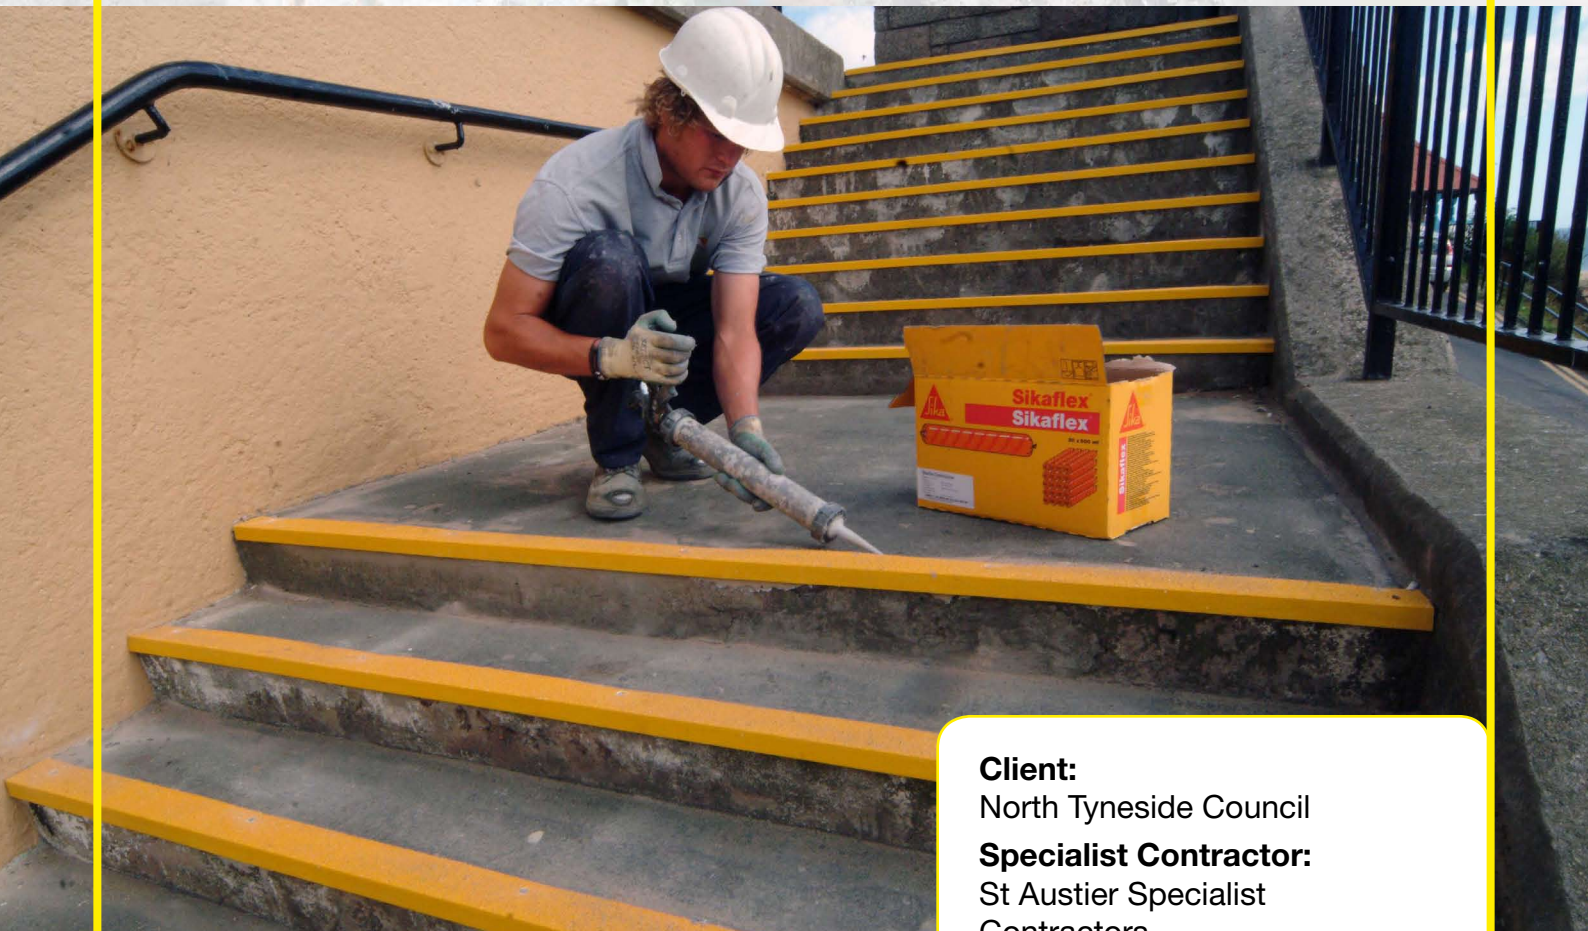
The public access steps down to Cullercoats Beach in Tynemouth had deteriorated due to wear and marine exposure over time. This was giving North Tyneside Council cause for concern over continuing to ensure public safety. Therefore St Astier Specialist Contractors Limited were appointed to undertake repairs, plus an overall refurbishment and upgrading of the steps. Together with their specialist materials supplier **NCC**, they developed the ideal repair and upgrading system.

Firstly the concrete steps were thoroughly cleaned by waterjetting and mechanically, then the damaged areas were broken out. These were repaired to their original line and profile with Sikadur 41, a high strength epoxy repair mortar. Then to improve safety and slip resistance, Ronacrete's Ronadeck Tacktile preformed, non-slip nosings were mechanically fixed to each step. These high visibility, bright yellow profiles, were also bonded and sealed to prevent any future movement.

This was achieved using Sikaflex 11FC, an elastic waterproof adhesive and sealant with permanent elasticity.
