Station Bridge, Hoylake

Case Study

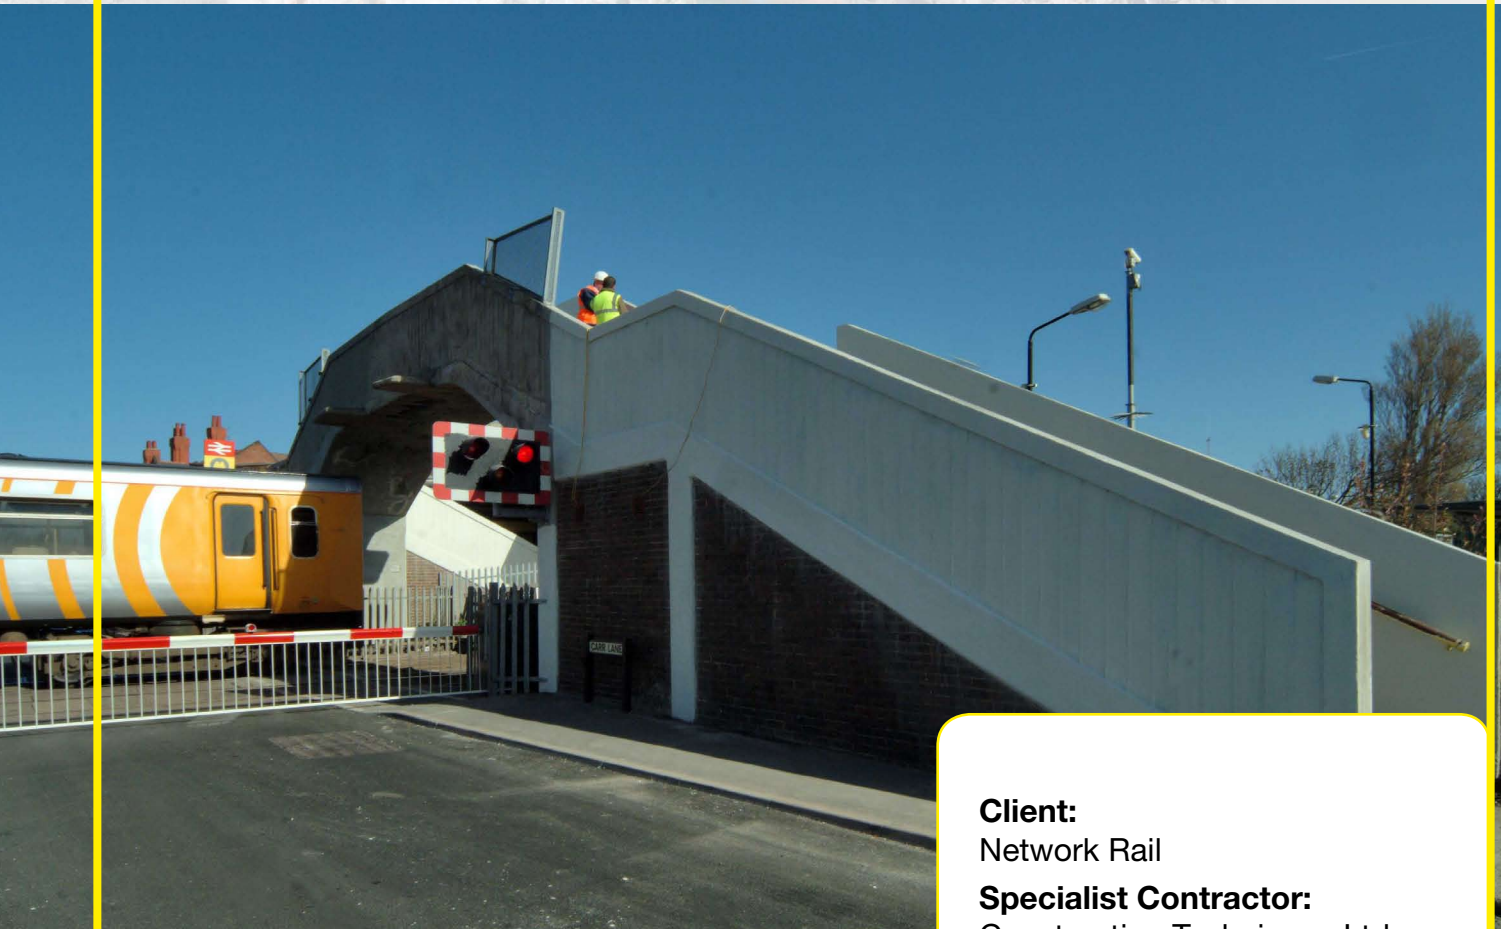
The concrete footbridge from the station, over the railway towards the golf course, was suffering from localised concrete spalling over corroding reinforcing steel. This was due to progressive carbonation and deterioration which had to be halted and future protection provided, all as part of the overall station refurbishment programme. Construction Techniques decided to use a full Sika Concrete repair and protection system provided by their specialist materials suppliers **NCC** in Chorley. This involved using specialist access to the structure with protection for passing trains that had to maintain a normal timetable throughout.

Firstly the concrete was thoroughly cleaned, then Sika MonoTop repair and levelling mortars were applied. Then Sikagard Elastocolour coating was used overall, to provide the long term crack bridging protection and anti carbonation resistance.
