Guggenheim Museum New York, USA

EMSEAL Colorseal

Case Study

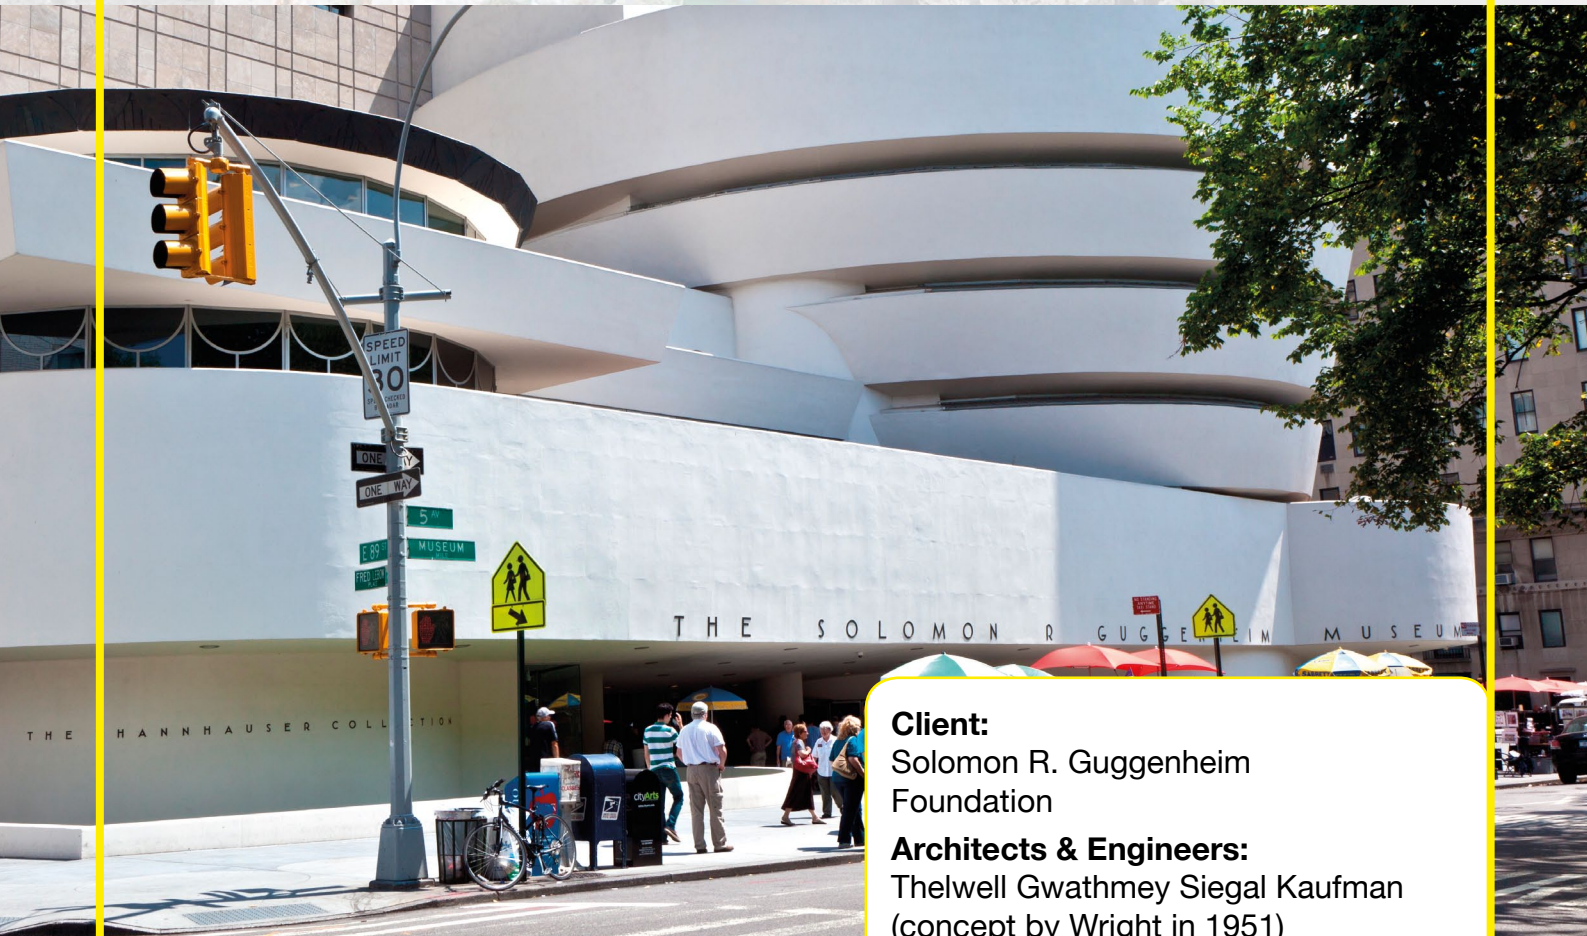
Where's the EMSEAL Colorseal? - The joint is between the limestone-faced building extension on the left of Frank Lloyd Wright's iconic original and the darker neighbouring brick building to its left.

For most designers expansion joints are a necessary evil – and 'Evil' for their disruption of design aesthetics – although when cleverly positioned, as in this case returned and rebated slightly back from the building face, the joint becomes a part of the shadow line. From just 2-3m away the joint remains essentially a shadow-line although it was colour matched with the limestone facade as seen when viewed from close-up.

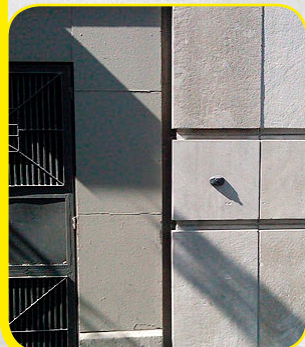
The EMSEAL Colorseal is fully intact and securely non-invasively bonded to both sides of the joint. The material is resilient and responsive, the stored energy of pre-compression remains very evident and there are no signs that the material is degraded or suffering in any way that might constrain its ongoing performance.
