Alexandra Square Underpass, Lancaster

Case Study

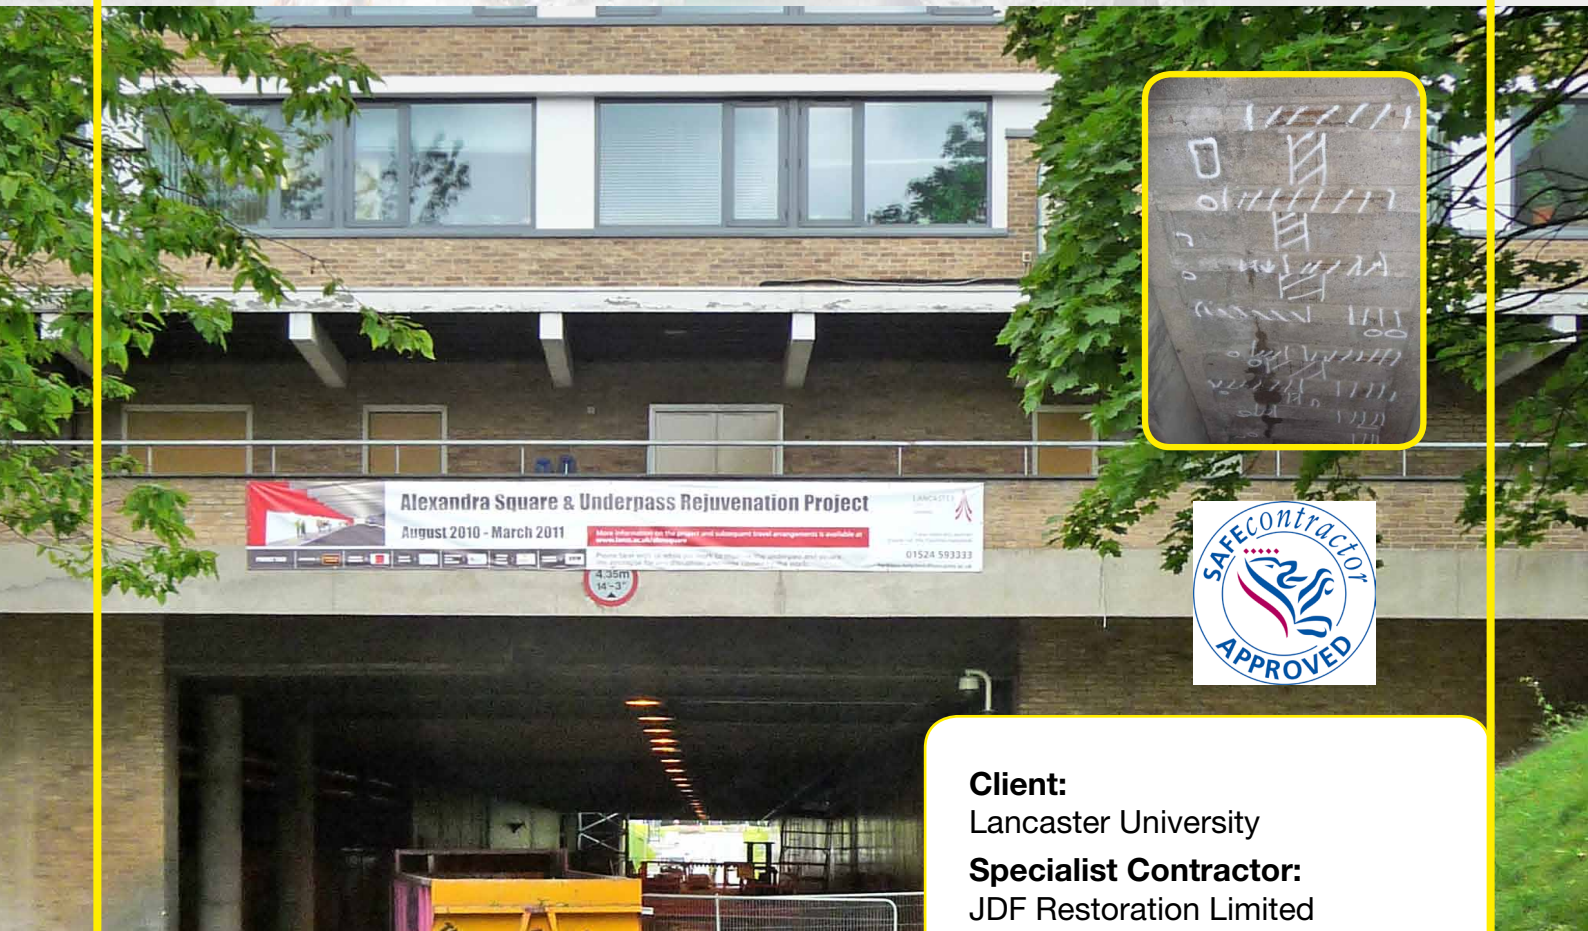
Concrete spalling from the soffit over the roadway through the underpass was evident due to carbonation and chloride induced reinforcing steel corrosion. The Engineers required the exact extent of this damage to be determined as part of the repair works as this made considerable savings in access cost and time.

After competitive tendering all of the works were carried out as a complete package by JDF Restoration, including the Condition Survey to determine the precise nature and extent of the damage; production of a Detailed Specification with the most appropriate repair materials; Bills of Quantities, and then installation and application of the concrete repair products and systems. The solutions included installation of Cathodic Protection using a sacrificial anode system, followed by a pre-batched, quality controlled, sprayed concrete overlay.
