Parking Structures

Liabakken Boligsamaie Apartment Complex, Near Oslo, Norway

Case Study

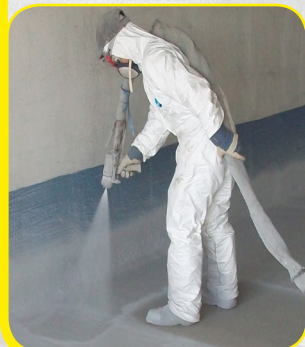
This Apartment Complex outside Oslo, wanted to repair, seal and protect their existing, partially below ground, multi-storey parking garage decks that had started to deteriorate. They needed to ensure that the decks were watertight to prevent water and de-icing salt ingress to the structure and / or onto the vehicles parked in the lower decks. The three decks totaled 5,200m² and after repairs the deck coating system was also required to provide a highly abrasion and wear resistant, anti-slip surface and yet still be easy to clean and maintain a good aesthetic appearance.

Consolvo AS the Facilities Maintenance Contractor, contacted the specialists at Jetmen Protection, who recommended a full VIP Quickspray repair and protection system based on polyurea resin. The VIP system included fast-setting penetrative primers to seal the substrate, fast setting repair mortars and the deck coating which also cures and hardens rapidly, but still allows a broadcast surface profile to be built-up and provide the skid resistance required.

The procedure was for all of the concrete surfaces to be blastcleaned, the damaged areas repaired, and then the whole area was primed and coated with the VIP Quickspray using hot airless spray techniques with graded fine aggregate broadcasting into the penultimate layer.
