## Almetron Limited, Wrexham, North Wales

## Case Study

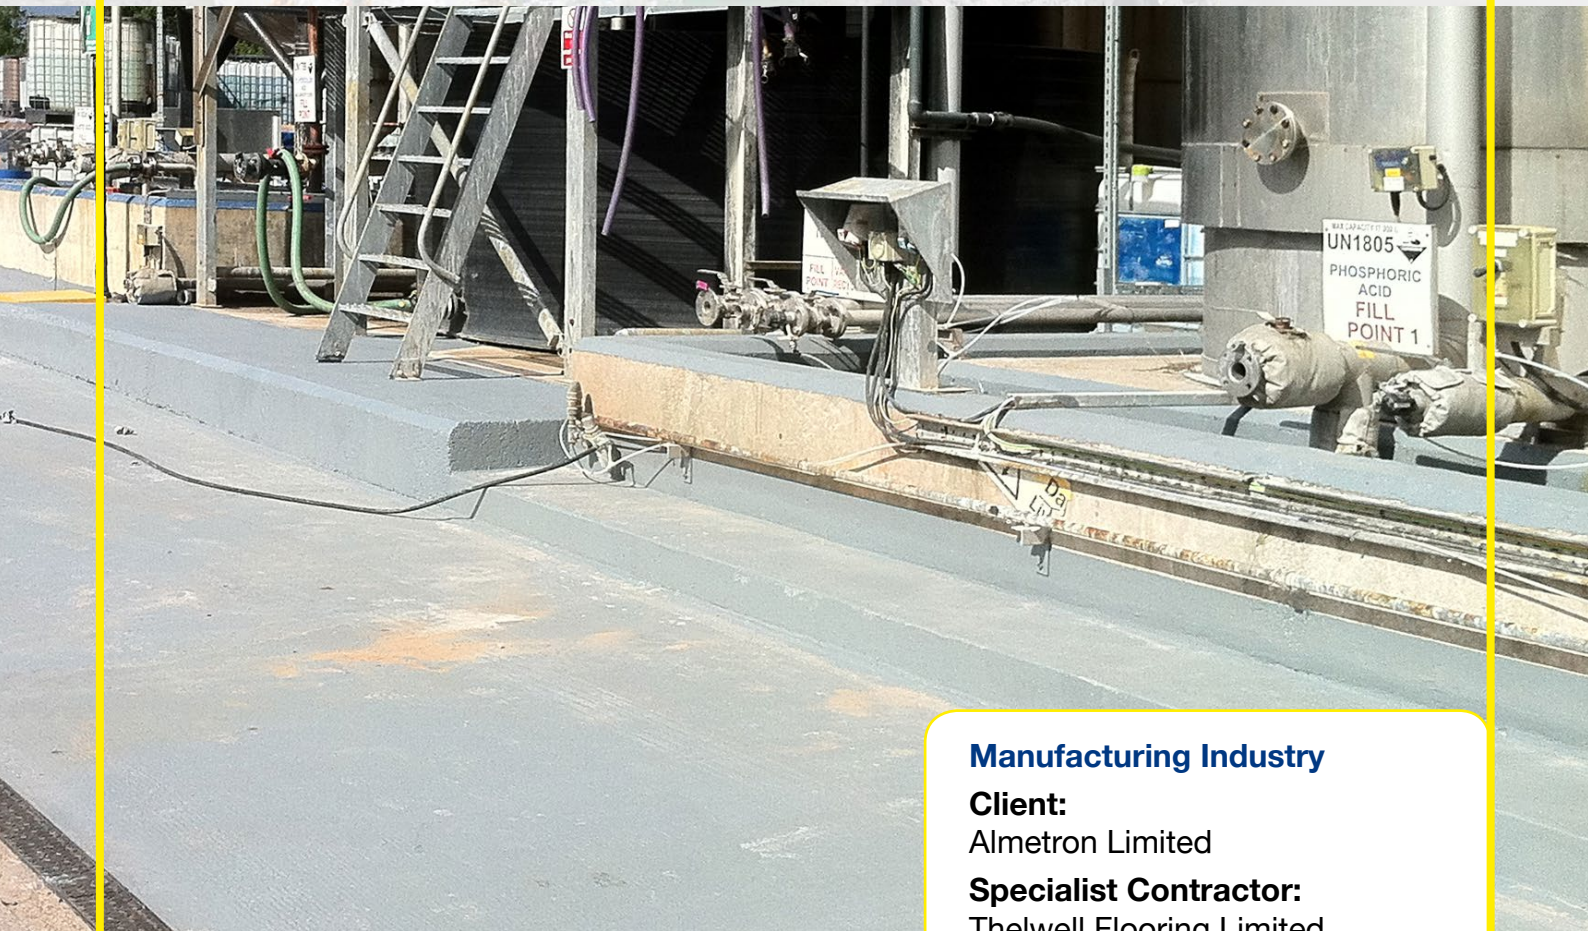
Almetron supply specialist chemicals, particularly for the metals finishing industry and these are produced at their plant in Wrexham, North Wales. All manufacturing on the site is undertaken with great consideration for the environment, however the necessary production processes involve several particularly aggressive chemicals. These include especially strong acids that require safe handling and use, especially the concentrated Phosphoric Acid ( $H_3PO_4$ ), which is particularly aggressive to concrete and this had started to attack the surfaces in the chemical containment areas.

In the bulk IBC and tanker off-loading areas, the Almetron plant engineers wanted to repair this damage and then protect all of the surfaces with a durable and highly acid resistant coating system. Therefore all of the concrete damaged by acid attack was broken out and removed, then thorough mechanical preparation of all of the concrete surfaces was carried out by blastcleaning.

Concrete repairs were carried out with polymer modified mortars from NCC and then the selected ATB-300 RC System was applied to protect all of the repaired floor and wall surfaces. The ATB-300 System is based on advanced vinyl ester resins that provide extremely high chemical and mechanical resistance – especially to strong acids, to ensure long term protection.
