## **Wythenshawe Flats, Manchester**

# **Case Study**

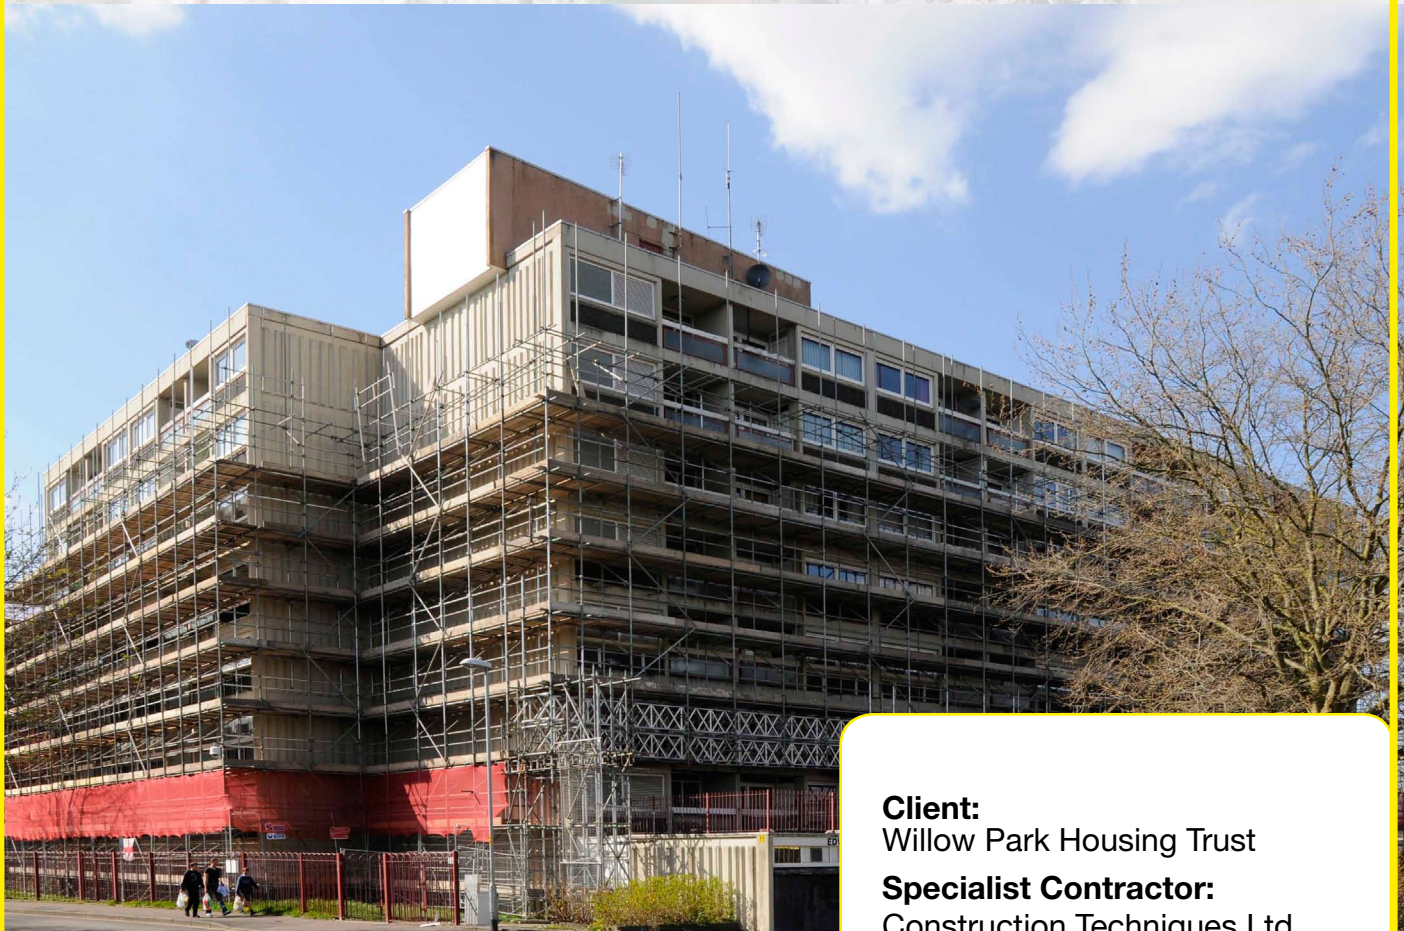
Early in the works they discovered that the edges of the concrete floors, balconies and other exposed concrete surfaces were cracked and spalled in many areas, due to carbonation and water ingress leading to steel reinforcement corrosion.

A complete Sika MonoTop concrete repair and protection system was used to protect the cleaned steel, replace the damaged concrete and then provide future protection with the waterproof, anti-carbonation coating Sikagard 675W.
